FAILURE ANALYSIS OF 18-INCH DIAMETER GAS PIPELINE

Faizul Hasan and Javed Iqbal

Department of Metallurgical & Materials Engineering
University of Engineering & Technology, Lahore, Pakistan

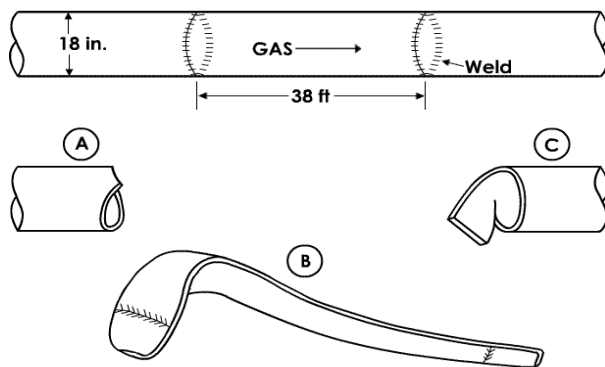
Figure 1. Schematic illustration of the geometry of rupture. A ~40 ft long portion of the pipe, labeled 'B' broke off the main line, and was thrown away to a distance of ~50 feet.

At about 0840 hours on 3 November 1993, the 18-inch diameter main gas pipeline ruptured at about 8 miles downstream of compressor station 'AC1'. The rupture occurred in a 38 feet long section of the pipe, and extended a few feet beyond the weld-joints at both ends. This is schematically illustrated in Figure 1. As a result of the rupture, a portion of the pipe had separated from the main line and was thrown away to a distance of about 50 feet. The separated piece of pipe is labeled as 'B' in Figure 1, while the corresponding pipe upstream has been labeled as 'A', and that on the downstream side as 'C'.

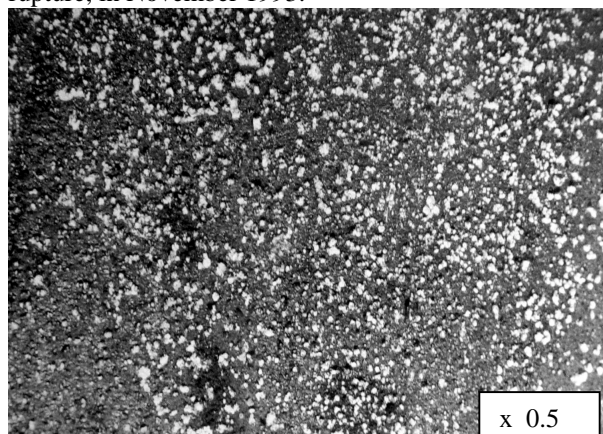
Figure 2. Small-sized white deposits on the pipe surface, exposed by gently peeling-off the coating from piece 'A' of Figure 1. These were identified to be carbonates and bicarbonates of sodium.

On the fractured piece 'B', the coating had been completely removed from the entire surface of the pipe, presumably due to the flattening of the pipe-sheet during rupture. However, piece 'A' had most of its coating present on it. At many locations the coating had lost its adherence to the pipe surface and was easy to peel-off. When the coating was gently removed, the pipe surface was found to be covered with a significant amount of 'reddish-brown' rust. Additionally, very small-sized patches of a white deposit were also present on the pipe surface. These deposits, shown in Figure 2, were carefully scrapped off the surface and analysed by X-ray diffraction.

The diffraction results showed the presence of iron-oxides, iron-carbonate, sodium-bicarbonate and quartz. The quartz was believed to have come from the surrounding soil, fine particles of which may have seeped through the microcracks in the coating.

The above observations clearly show that the coating on the pipe surface had deteriorated, i.e., it had developed ‘disbonds’ as well as ‘holidays’. This in turn also means that a ‘corrosive environment’ had been present between the coating and the pipe surface. The presence of carbonates and bi-carbonates further indicates that a high-pH environment must have been present for a considerable length of time [3].

The two pre-requisites for the SSC, i.e., the stress and the corrosive environment were also present in the present case: the hoop stress of the level of ~65% of the SMYS caused by pressurized gas (see Section 2.2), and the corrosive environment, evidenced by the rusting of the pipe-surface beneath the coating, as well as the presence of carbonate and bi-carbonate of sodium, shown in Figure 2.

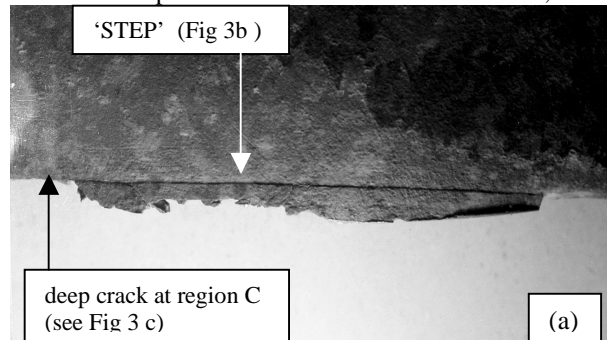
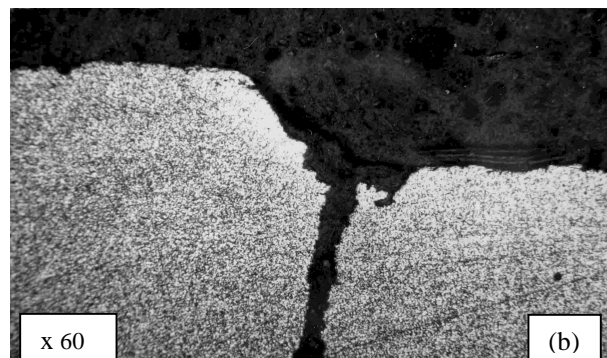
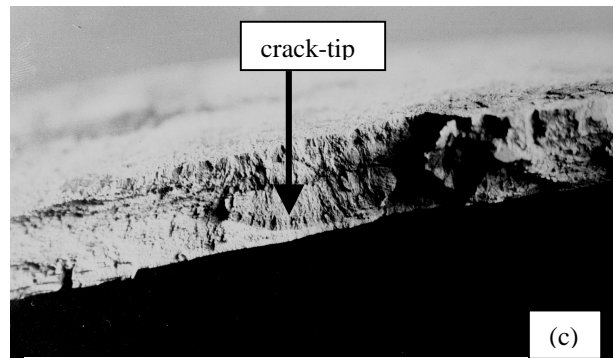
The entire fractured face on the rupture piece ‘B’ was closely examined with a magnifier (of magnification x10). The location at which the rupture had initiated was identified with the help of ‘chevron’ marks [4] on the fracture-surface. Photographs showing the details of the region of the crack-initiation are given in Figure 3.

More than one longitudinal (or axial) cracks had formed in this area, while the crack of greatest depth, where the rupture is believed to have initiated, had

Figure 3. (a) The fractured edge of the pipe showing a longitudinal ‘STEP’ on the outer surface of the pipe, (b) The crack formed at the root of the step – ‘the stress raiser’, and (c) The deepest crack observed on the fractured-face, where the fracture is believed to have initiated .

formed at region ‘C’, indicated in Figures 3a and 3c. It may also be noted in Figure 3a and 3b, that there was a longitudinal ‘step’ present on the pipe surface, and that the region ‘C’ existed on this ‘step’.

It was also important to note that the entire length of the ruptured pipe had actually parted along the ‘step’. This observation suggests that cracks must have formed at many points on the ‘step’ along the length of the pipe.

It shall be quite relevant to mention here that this ‘step’ was a manufacturing defect. During the manufacturing of the pipe by electric-resistance welding method [5], the weld-flash on the outer surface of pipe has to be neatly removed so as to leave a smooth surface free from any stress-raisers like steps or grooves. In the present case, however, it appears that that the weld-flash was removed with a shaving tool which was not properly aligned or shaped in accordance with pipe surface, and this had given rise to the formation of the longitudinal step. This explanation is schematically illustrated in Figure 4.

In the present failure, however, it seems highly probable that the time-to-rupture may have been markedly reduced by the stress-raiser that was present on the pipe surface. The longitudinal step on the outer surface of the pipe that was produced during the manufacturing, through careless shaving of the weld-flash, had acted as a very effective stress-raiser. The stress concentration at this step had in effect locally increased the value of Hoop stress in excess of $PD/2t$, thereby accelerating the stress-corrosion cracking of the pipe. The present study thus also emphasizes the need to take due care during the manufacturing of the pipe, so that no stress-raisers like steps or grooves are left on the pipe surface after the weld-flash is removed.

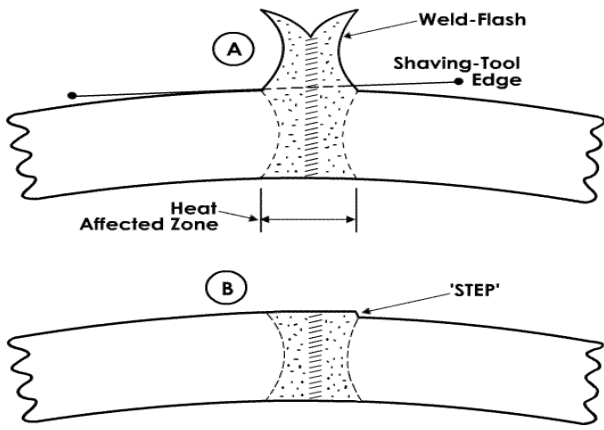
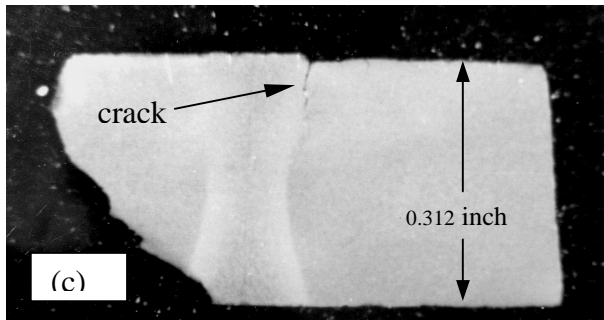
Figure 4. A schematic illustration of the formation of longitudinal step on the outer surface of the pipe during manufacturing. The shaving-tool edge indicated in the top part of the diagram, should have been carefully aligned in accordance with the profile of the pipe-surface, so as to leave a smooth surface.

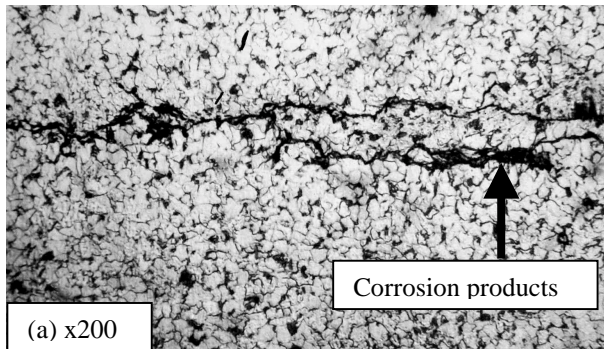
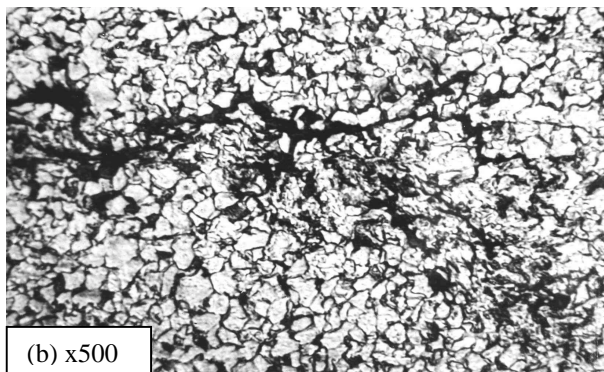
Microstructural examination of the samples taken from the area shown in Figure 3b, was conducted to study the morphology of the crack. The micrographs given in Figure 5 show that: (a) the cracks were, in general, intergranular, (b) the cracks exhibited extensive branching, and (c) corrosion products (dark-etching) were also observed to be present inside the crack.

These three characteristics, which are typical features of stress-corrosion cracks [1,2,4], clearly suggest that the failure was caused by stress corrosion cracking.

Figure 5. The micrographs taken from the sample shown in Figure 4 c, showing the intergranular morphology of the crack. The extensive branching of the crack, as well as the corrosion products inside the crack may be noted.

In the present rupture, the presence of deep cracks without any significant attack on the pipe surface (Figures 3, and 4c), the inter-granular nature of the cracks, and the branching exhibited by the cracks (Figure 5), clearly support the view that the present rupture was caused by SSC.
