ANALYSIS OF THE CAUSES OF FAILURE OF SOME SURGICAL HARDWARE

S. Dey, Q. Ahsan and A.S.M.A. Haseeb

Department of Materials and Metallurgical Engineering, BUET, Dhaka

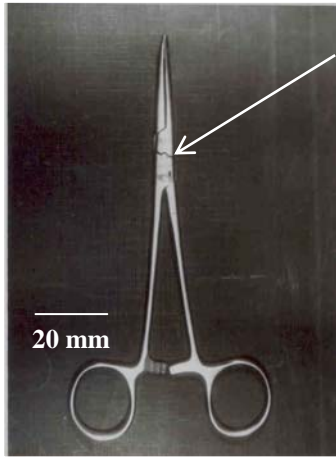
A number of different types of forceps, which failed prematurely, were collected. The failed forceps were visually examined. The forceps mostly failed by cracking. Cracks were found to occur mainly near the rivet (fig 1a) and at area where there is a sharp change in cross section (fig 1b). A close-up view of a crack near the rivet of an artery forceps is shown in fig 1c. In addition to cracks, the failed forceps also contained rust spots, reddish brown in colour. The rust spot were few in number and mainly found in the lower portion of the forceps, which is used for gripping. Rust spots also occurred at the internal faces near the rivet the size of the rust spots was small, less than a millimeter across. Rust product adhering to a crocodile forceps is shown in fig 2. Investigation revealed that cracking took place near area where rust

Fig 1(a). Crack in an artery forceps (indicated by an arrow).

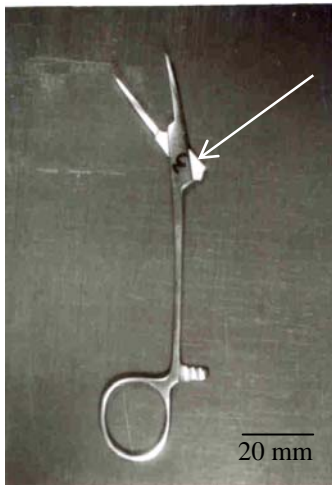
Fig 1(b). Fractured artery forceps (indicated by an arrow).

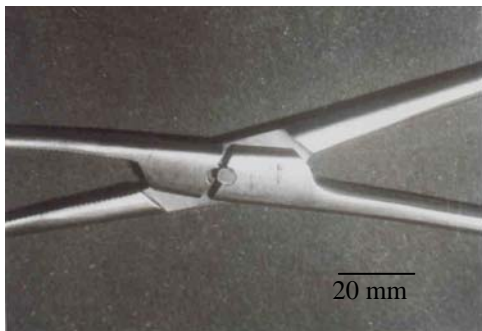
Fig 1(c). Crack in an artery forceps (indicated by an arrow).

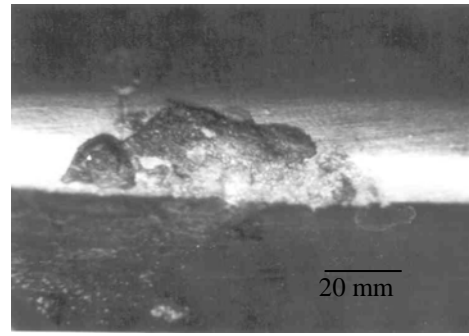
Fig 2. Rust products on the surface of a crocodile forceps.

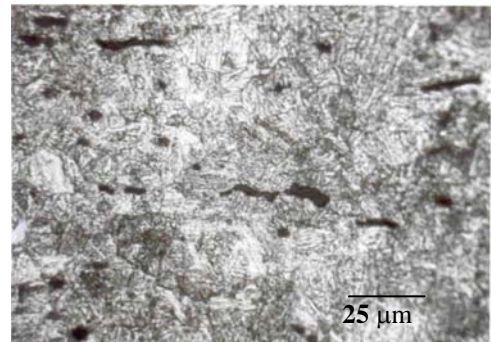
Optical micrograph of a failed sample in the etched condition reveals that its microstructure contains tempered martensite and inclusions(fig 3).

Fig 3. Optical microstructure of failed sample.

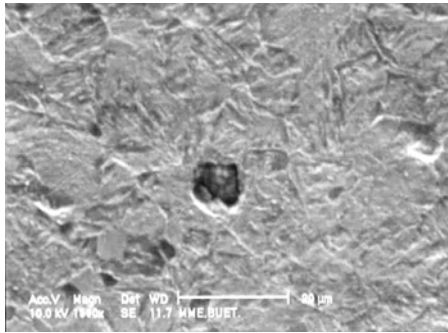
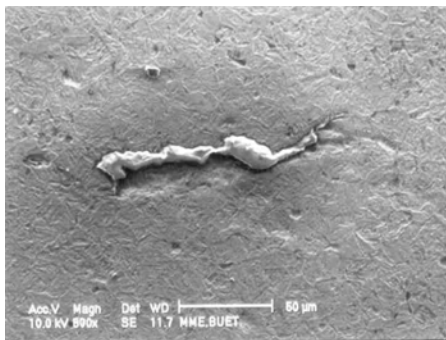
Fig 2 further reveals that the failed samples contain numerous round as well as elongated black features. Under SEM (fig 4a) these features are found to be inclusion/slag.

Fig 4. SEM microstructure of artery forceps (a) round inclusion (b) elongated inclusion on which EDX carried out.

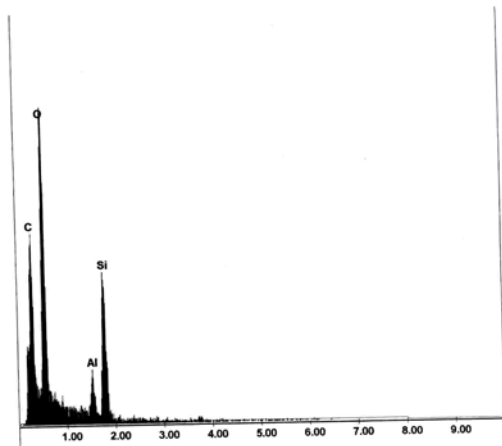
Microanalysis by EDX reveals that the slag exhibited in fig 4b contains silicon, aluminium and oxygen (fig 5). Carbon is also found due to contamination. Thus the slag is basically identified as of alumino-silicate type.

Fig 5. EDX analysis of inclusion in failed artery forceps.

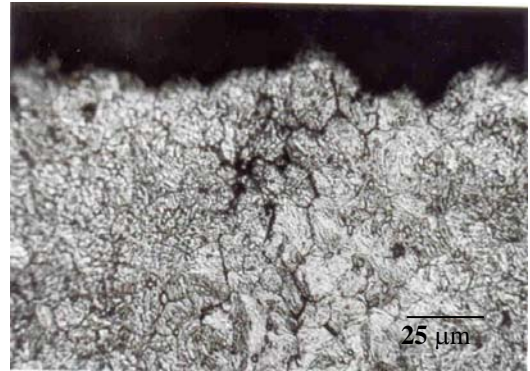
Fig. 6 shows a cross-sectional micrograph of a failed forceps taken at a cracked region. The main crack is running horizontal at the top portion of the micrograph. Secondary cracks are seen running down. The crack morphology is intergranular in nature.

Fig 6. Optical microstructure showing intergranular cracks in failed forceps.

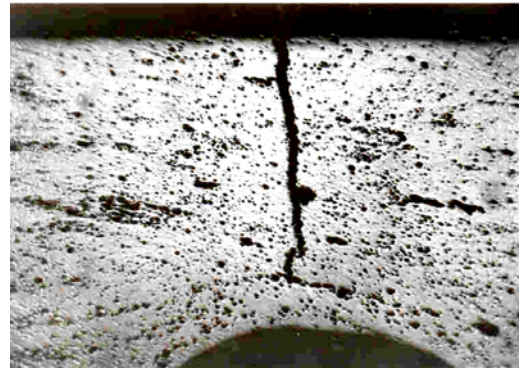
A polished section containing a crack was examined without etching at a lower magnification (fig 7a). The crack occurred near a riveted hole, which is seen at the lower portion of fig 7a. The crack started at such a location where stress is supposed to be high when the forceps is in use. On the contrary optical micrograph (Fig 7 b) of a good sample under unetched condition shows less amount of inclusions. It is seen in fig 7a that the unetched polished section contains numerous dark spots.

Fig 7. Optical microstructure (a) showing crack around inclusion population in failed crocodile forceps (b) of a good forceps.

As has been shown earlier, these spots are actually slag/inclusion. Presence of such large amount of inclusion is not expected in clean steel. The morphology of the crack shows that the propagation of the crack is assisted by the presence of inclusions.

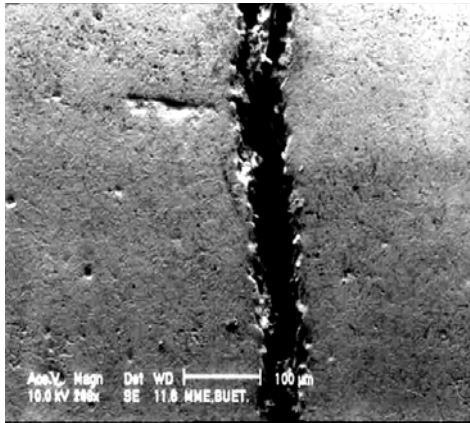
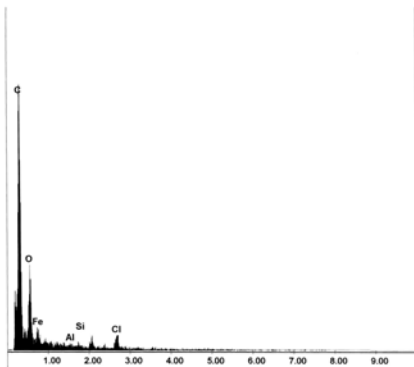
The crevice inside the crack (fig 8a) was analysed by EDX and the spectrum is shown in fig 8b. The spectrum reveals the presence of chlorine inside the crevice. It may be noted that water used for cleaning the forceps is one of the hospitals where failure occurred was also tested for chlorine. A large amount of chloride ion was found to be present in water.

Fig 8 (a).SEM microstructure showing secondary crack on crocodile forceps and (b) EDX analysis on crevice of the crack of crocodile forceps

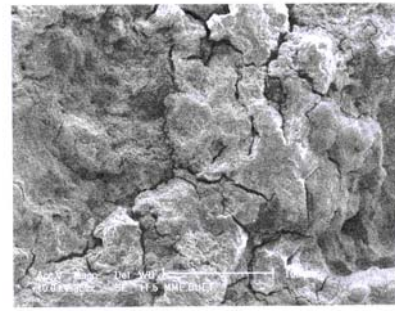
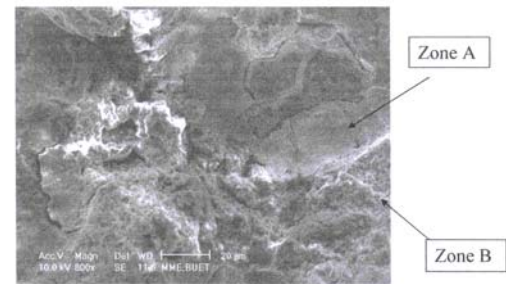
Scanning electron microscopy was carried on fracture surface of failed forceps and it clearly shows the intergranular mode (fig 9a) and mixed mode of intergranular and transgranular (fig 9b) fracture.

Fig 9. SEM of fracture surface showing (a) intergranular and (b) mixed mode of intergranular (zone A) and transgranular (zone B) type.
