## REFURBISHMENT OF THE COOLING SYSTEM OF THE 3 MW TRIGA Mk-II RESEARCH REACTOR OF BANGLADESH

### ABSTRACT

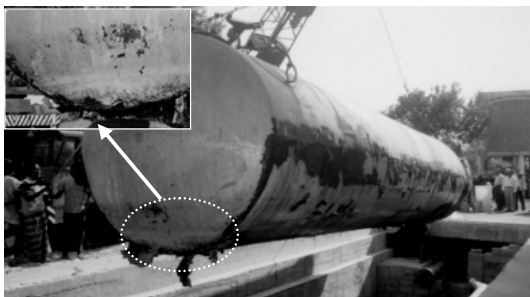
A leakage was detected in the decay tank of the primary cooling system of the 3 MW TRIGA Mark-II research reactor on 14 July 1997. About 45,000 litres of de-mineralized water with an activity concentration of

about 28 Bq/litre due to the presence of  $^{58}\text{Co}$ , leaked out from the primary cooling loop. The water was collected and contained in a special storage and in plastic containers. The tank was isolated and then removed (Fig 2), and tested both non-destructively and destructively.

Extensive corrosion and pitting were found in a particular area where rain water seeped in during the monsoon and remained logged for a long period of perhaps a number of years. Upon inspection, corrosion and pitting were also observed on the inner walls/baffles of the decay tank. It is to be noted that a leakage in the primary cooling loop of the reactor could have caused loss of coolant accident (LOCA) to occur. However, in the case presented here, it was possible to avoid LOCA because of the passive safety system which had been incorporated into the design of the primary cooling loop through the use of anti-siphon vent line at appropriate location of the outlet piping of the primary cooling loop (Fig 3).

Fig 2: Removal of the damaged N-16 decay tank

On 27 July 1998, a jumper connection was installed in place of the decay tank. With this jumper or decay tank bypass connection, the reactor was made operational at a power level of 250kW (high power operation was not possible without a N-16 decay tank). During 2000 – 2001, a new decay tank was installed and at the same time several modifications in the primary cooling loop such as replacement of the tube-shell type heat exchanger with a plate type heat exchanger, replacement of the 'T' connection at the discharge of the pumps with a modified 'Y' connection, etc. were implemented so as to make the reactor operational again at full power.

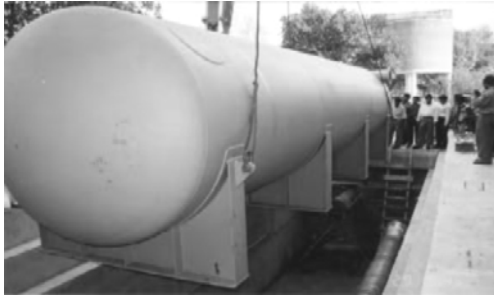
Fig 4: New decay tank with aluminium saddle

A new decay tank with four aluminium saddles welded to its body was installed in the decay tank room. Each saddle was anchored to floor with four steel routed bolts (3.175 cm dia, 22.86 cm long). The saddles were bolted to the floor in a way such that one of the saddles remained fixed and the other three could slide on the floor. Sliding saddles were used in order to allow thermal expansion of the large decay tank having a length of about 10 m and a diameter of about 2.5 m. New decay tank with aluminium saddle is shown in Fig. 4.

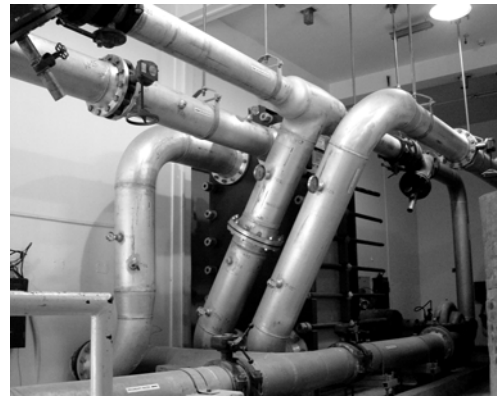
Fig 5: Plate type H/E with modified piping arrangements

A new plate type heat exchanger was installed replacing the old shell and tube type heat exchanger, which got heavily fouled. The new heat exchanger required several changes in the piping layouts of both the primary and the secondary cooling loops. The new heat exchanger with modified piping arrangements is shown in shown Fig 5.

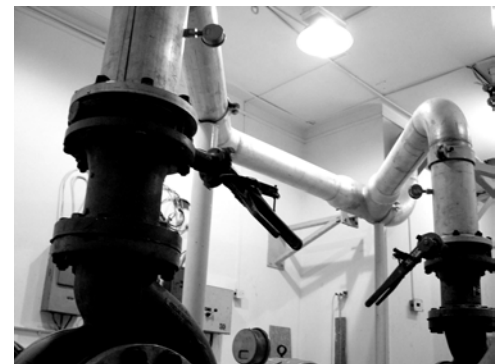
A modified Y-connection (Fig 6) was introduced in place of the T-connection at the discharge side of the two 50-hp pumps, which are operated simultaneously to get the desired primary flow rate of 13,230 liters/minute (3,500 US gallons/minute). It may be mentioned that a “T” connection in the discharge line of any pumps gives rise to “cavitations” like noise depending upon the degree of turbulence. The pumps in question had a history of vibration problems and one of the possible

causes could have been this turbulence. The “Y” connection in the discharge resolved the matter to a great extent.

Fig 6: Modified Y-connection replacing T-connection

From Table-2 it is observed that after installation of Y-connection and appropriate pipe supports, the vibration level of the primary pumps & motors have minimised significantly and thus ensured safer operation of the reactor cooling system.

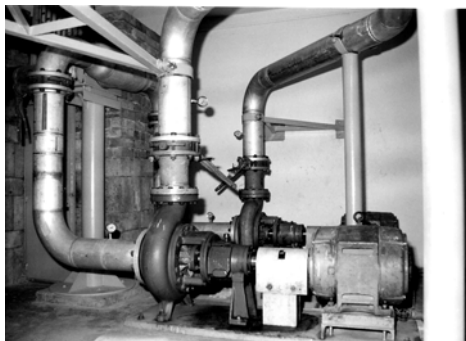
Fig 7: Modified pipe supports

Necessary pipe supports were provided at different locations of the primary and secondary cooling loops in order to reduce the vibration of the piping to a minimum level. Three types of mild steel (M.S.) pipe supports were used for this purpose. The types used include adjustable floor mounted type, adjustable roof mounted type and wall mounted type. In addition to these, a few supports, which were connected simultaneously to the floor and the wall, were also installed (Fig 7).
