NON-DESTRUCTIVE INSPECTION OF ABOVEGROUND PRODUCT PIPELINES OF SOME MANUFACTURING INDUSTRIES IN PNG

Lave Michael, John Pumwa, and M. A. Satter

Unitech NDE Centre
Department of Mechanical Engineering
PNG University of Technology, Lae, MP 411
PAPUA NEW GUINEA

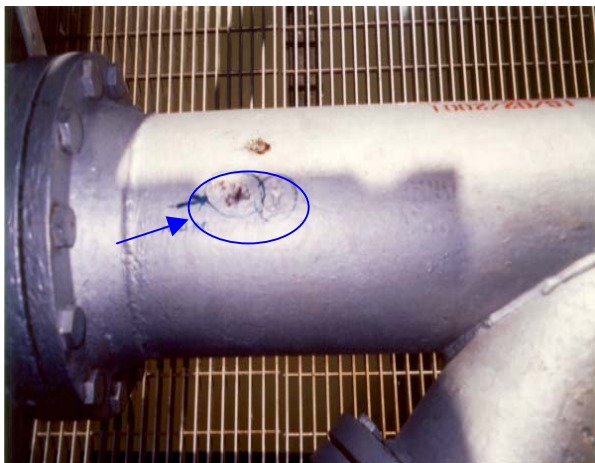
Figure1 - Arrow pointing to dent at wharf manifold.

However, on the contrary some of the anomalies that were detected in the course of visual inspection along the petroleum base product pipelines are listed below and are shown on Figures 1 and 2:

- Blister
- Dent
- Pitting
- Pinholes
- Scratch

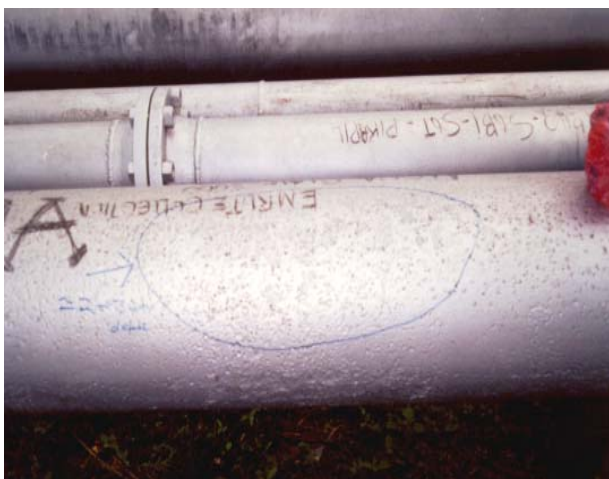
Figure 2 - Pitting on the surface of the 10 inches diameter pipeline.

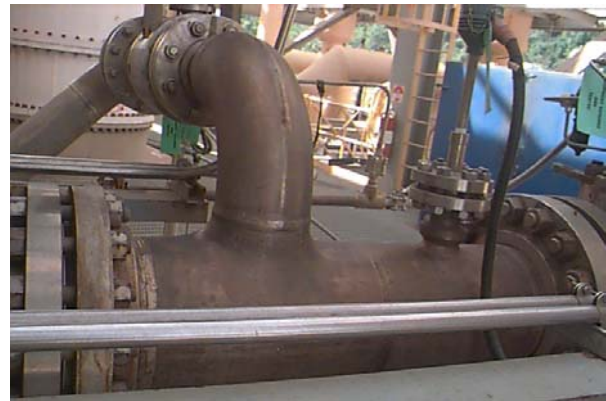
Figure 3 – Photograph illustration Auto-Clave slurry discharge T-joint titanium pipeline.

Ultrasonic testing has been widely utilized to monitor thin wall lining of pipelines and other plant components. Ultrasonic Thickness Gage (Dakota Ultrasonic MX – 3) single spot multiple measurement method was employed to determine the thickness measurements of the pipeline [3]. The gage had an accuracy of 0.01mm, less tedious and portable. These are the attributes that a NDT technician would greatly embrace since it makes the inspection more comfortable and therefore less fatigue [4]. Thickness survey was employed at a processing plant of a gold mine as shown in Figures 3 and 4 to determine the thickness at the slurry discharge pipe T-joint and elbow.

Of the many UT thickness survey conducted for the industries in PNG, these observations were made after analyzing series of thickness measurement results. Obviously, this has been greatly attributed to erosion rather than corrosion from both externally and / or internally. The results revealed the following trends:

- For all the liquid base fluids, the pipes were much thinner at the bottom than the top.

All liquid base fluids were pumped at high pressure from one point to another over several hundreds and even thousand meters. As the fluids make their journey along the lengthy pipelines, gravity acts on the fluid and particularly it's effect at every contact point of the fluid and the inside pipe wall. The effect of gravity is higher at the bottom of the pipeline and is least on the top of pipeline since is directly proportional to the mass of the fluid. And as such, the effect of erosion was much higher at the bottom inside wall of the pipeline than the top, resulting to the above observation.

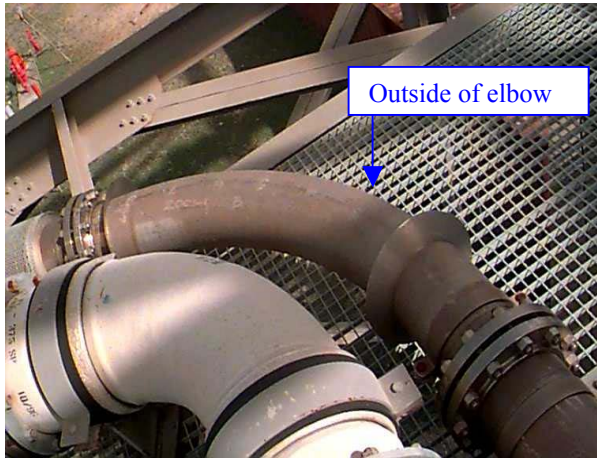
- At the pipeline elbows, the pipes were much thicker at the inside than outside diameter.

All fluids were pumped at high pressure along lengthy pipelines. When it turned at pipeline elbows, much of the fluid momentum is

greatest at the outside radius of the elbow than the inside radius of the pipeline due to the fluid velocity always been directed out [5]. As such, the fluid began to wear away the outside pipe wall surface resulting the trend observed above.

Figure 4 – Photograph of Auto-Clave slurry discharge titanium pipeline elbow.

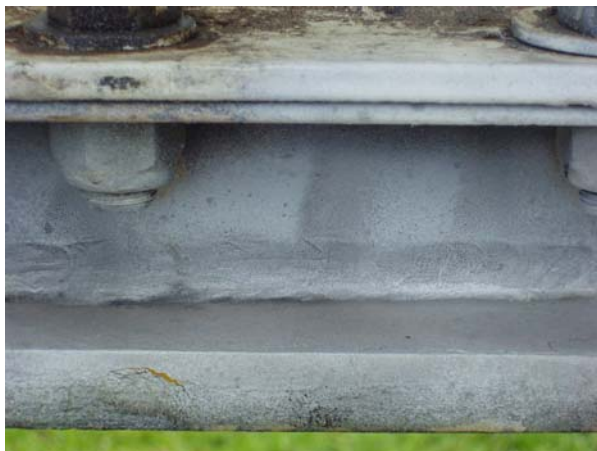
Figure 5 – Photograph white contrast paint being applied on fillet weld of the truck turntable.

In the course of inspection, the yoke revealed magnetic particle indication along some of the welded joints of the pipelines and other mechanical components like the truck turntable in Figure 5. It showed surface porosity and cold laps. Immediate actions were taken by the fabrication company upon notification to correct them.

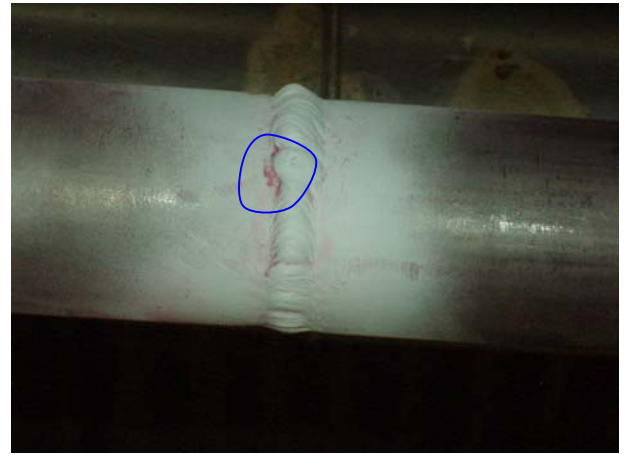
Figure 6- Photograph of Developer being applied on 2” stainless steel single butt weld

During inspections, cold laps and surface porosities were encountered on numerous occasions on welds as shown in Figure 6.
