## REFURBISHMENT OF THE COOLING SYSTEM OF THE 3 MW TRIGA Mk-II RESEARCH REACTOR OF BANGLADESH

### ABSTRACT

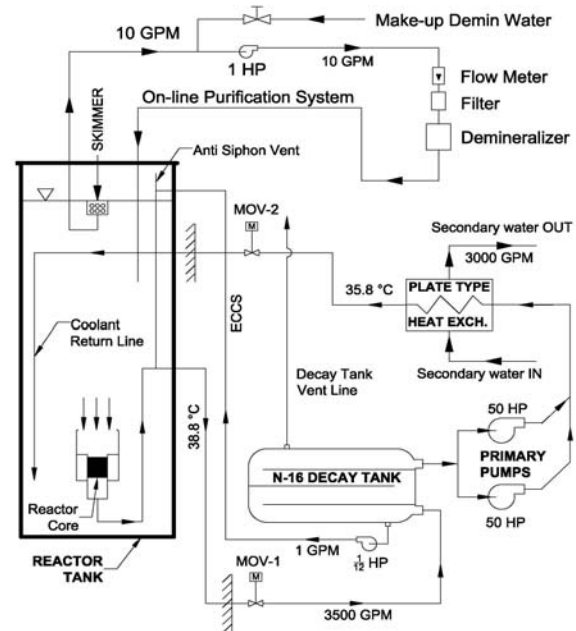
Fig 3: Primary cooling system of the research reactor

Extensive corrosion and pitting were found in a particular area where rain water seeped in during the monsoon and remained logged for a long period of perhaps a number of years. Upon inspection, corrosion and pitting were also observed on the inner walls/baffles of the decay tank. It is to be noted that a leakage in the primary cooling loop of the reactor could have caused loss of coolant accident (LOCA) to occur. However, in the case presented here, it was possible to avoid LOCA because of the passive safety system which had been incorporated into the design of the primary cooling loop through the use of anti-siphon vent line at appropriate location of the outlet piping of the primary cooling loop (Fig 3).
